**USD 387 Altoona-Midway
20704 US 75 Hwy
Buffalo, Kansas**

Public Notice & Request for Qualifications Construction Management at Risk (CMR) Services

Attention: Shawn Hensley
Subject: Professional Engineering Assessment of Damages to a School
Insured: Altoona Midway Elementary School
833 River Street
Altoona, Kansas 66710
Your File: 16915420
Date of
Incident: May 30, 2021
HDHY File: 21322

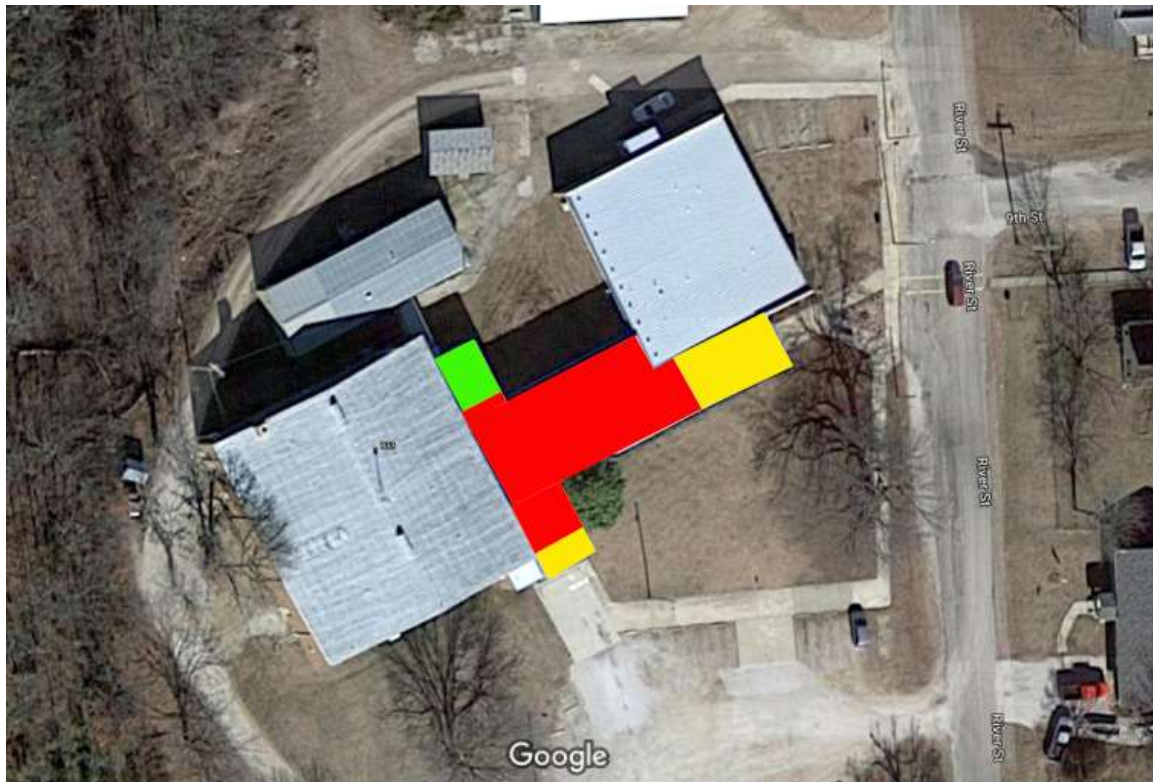
The damaged sections of the building are highlighted in Image 2. The green colored portion of the north building segment was not damaged. The red colored portion at the south end of the north building segment contains one (1) damaged 20-foot joist. The red colored section of the building sustained extensive structural damage to the roof and the walls. The yellow-colored segments of the L-shaped building have minimal damage or were not damaged by the fire. However, it will be more expedient to remove and replace these sections of the building to contain repair costs and to bring the building into conformance with building codes.

The secondary roof structure over this portion of the building was not heat damaged by the fire. However, the primary roof structure sagged causing the secondary roof structure to shift and lean. This roof structure will need to be removed and replaced to facilitate repairs to the primary roof structure.

Image 2: Color coded image of the building indicating areas of damage.

Fire damage to the L-shaped section of the school building is extensive. Repair of fire damage will require removal and replacement of the roof structure and finish over a 68-foot long section of the 40-foot wide east-west oriented section of the building. The roof and roof structure over a 20-foot by 64-foot section of the north-south oriented section of the building is also required.

The remaining sections of window wall along the south side of the L-shaped building should be replaced to conform to current building code requirements.

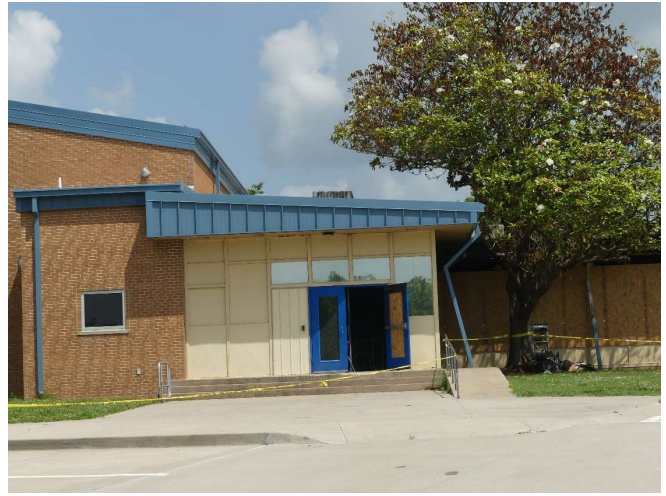
2. South end of the west, north-south, entryway to the center section of the building.

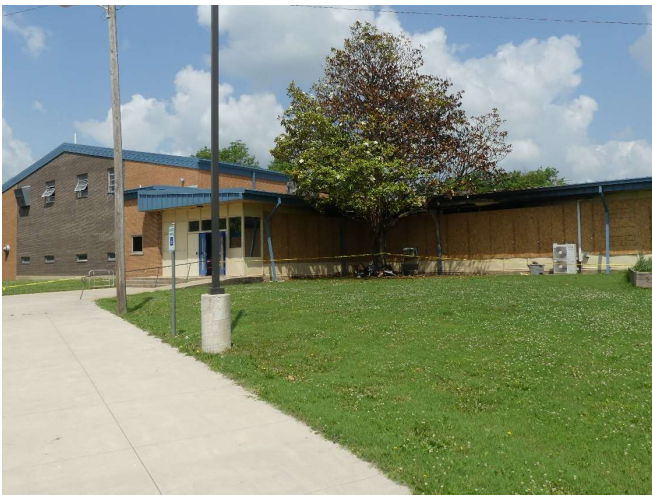
3. South side of the center section of the building.

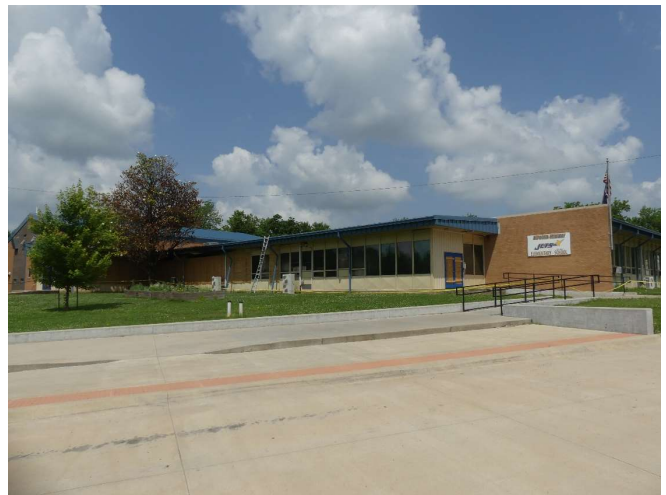
4. South side of the center section of the building.

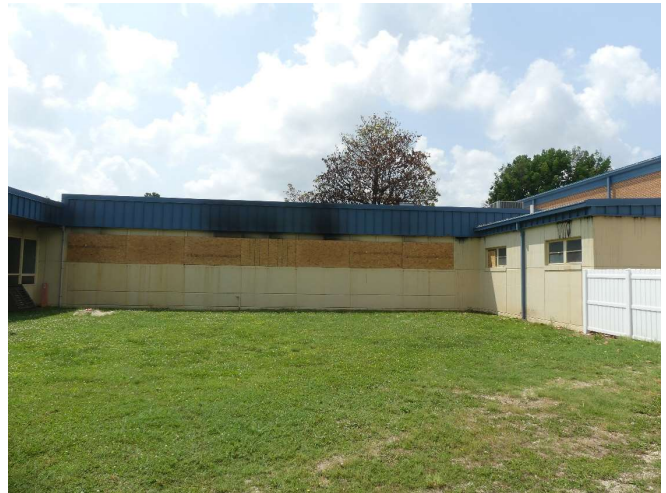
8. North side of the center building section.

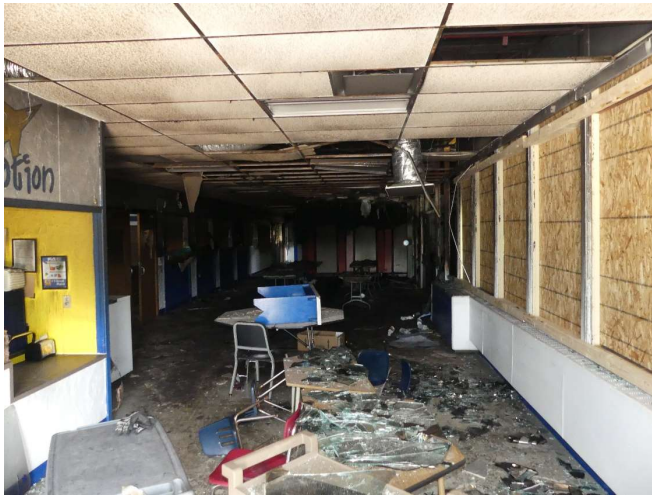
9. Looking north from the south end of the north-south oriented section of the L-shaped building segment.

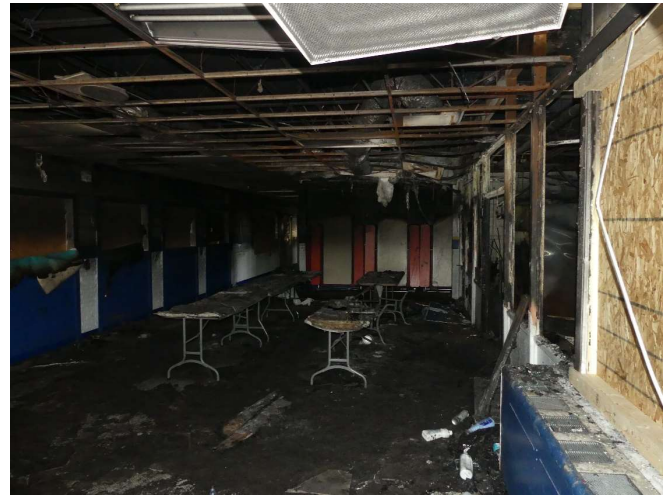
10. Looking north into the north-south oriented section of the L-shaped building segment.

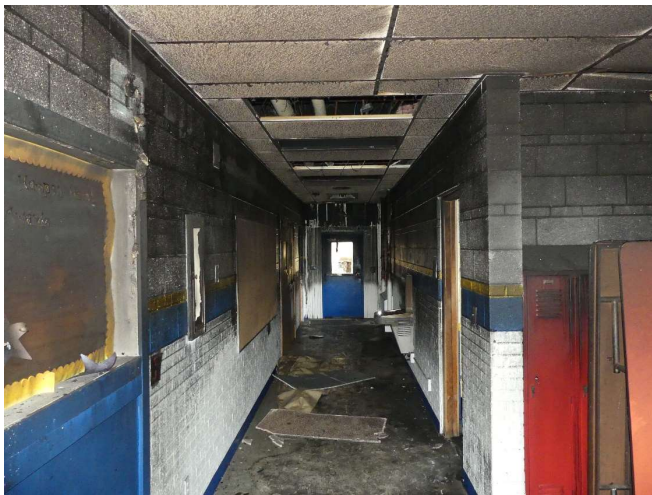
11. Looking north into the north projection from the north-south oriented section of the L-shaped building segment.

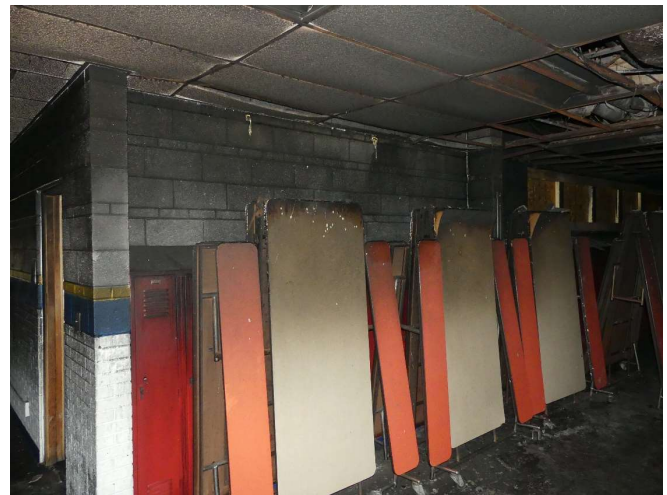
12. Block dividing wall at the north end of the L-shaped building segment.

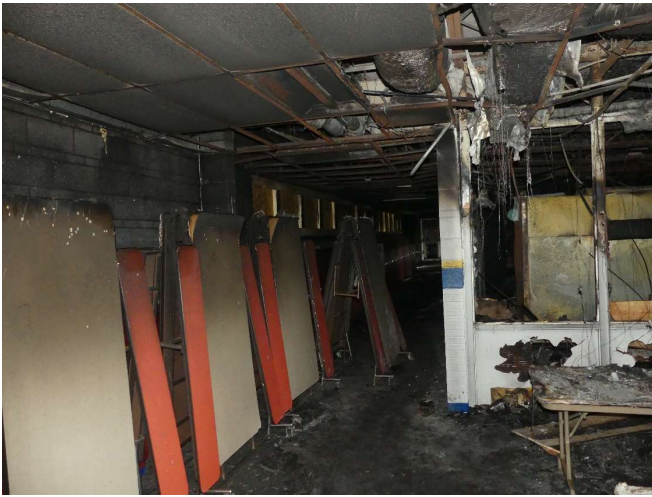
13. Looking east into the east-west hallway.

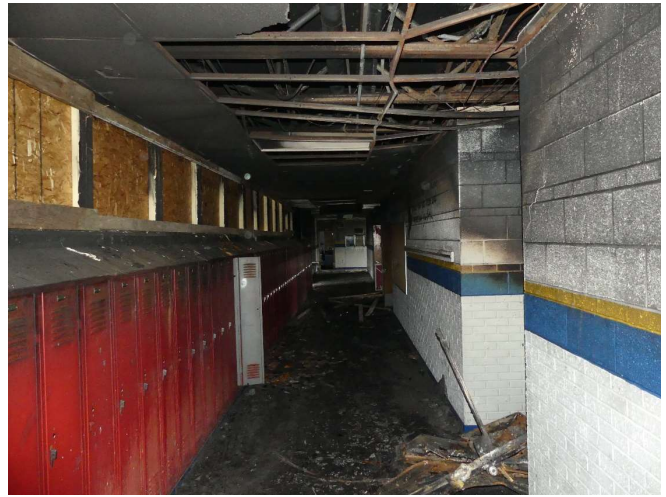
14. Looking east along the east-west hallway.

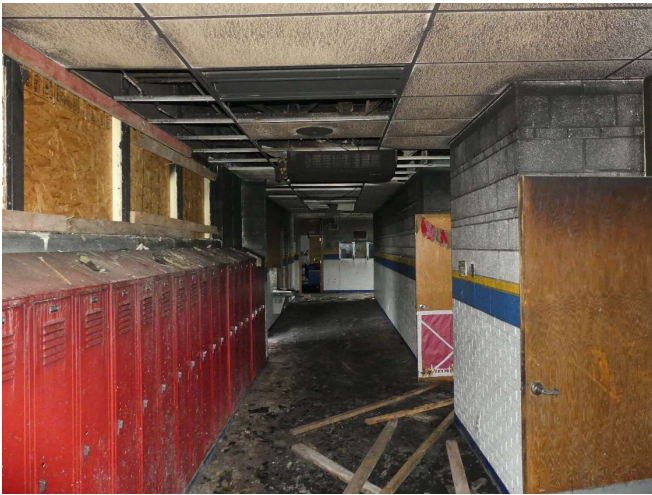
15. Looking east along the east-west hallway.

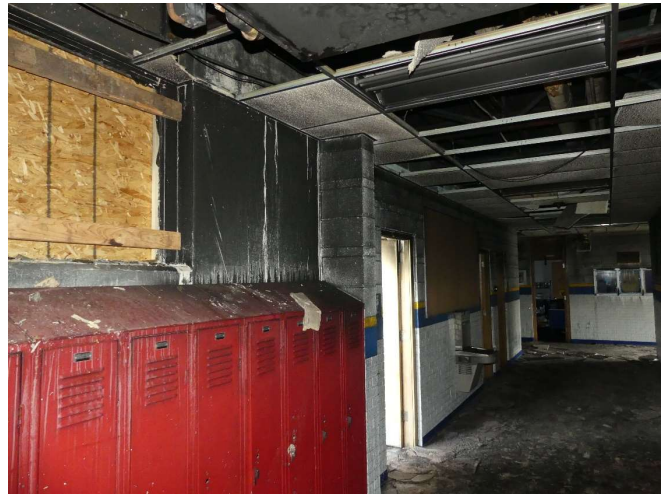
16. Looking east along the east-west hallway.

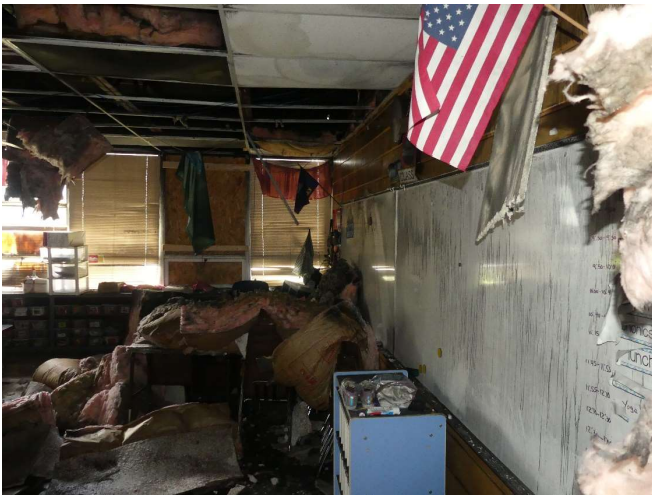
19. View into the east classroom in the east-west oriented building segment.

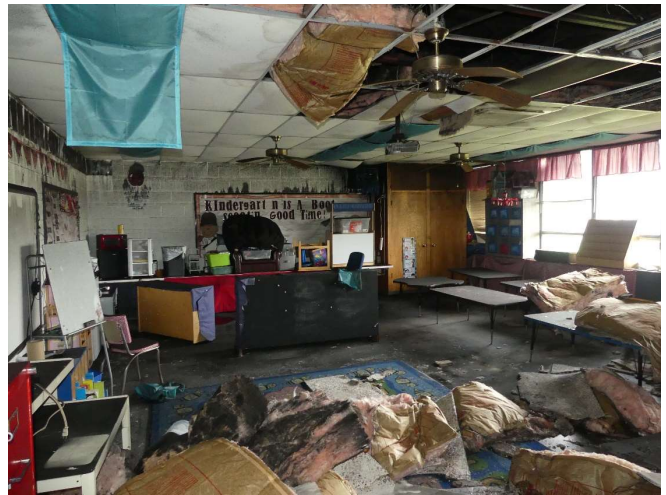
20. View into the east classroom in the east-west oriented building segment.

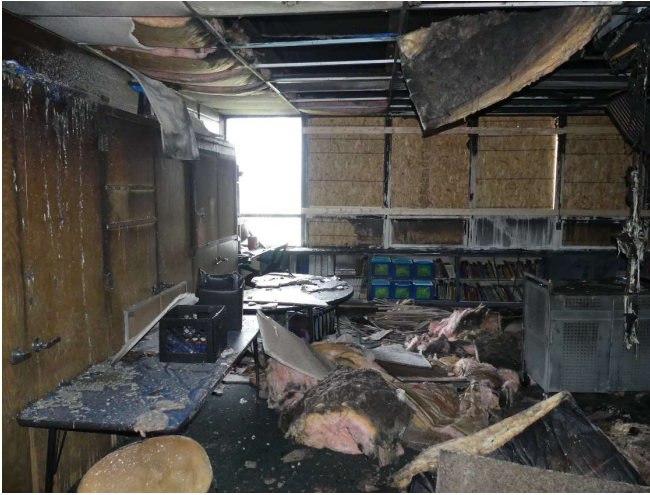
21. View into the west classroom in the east-west oriented building segment.

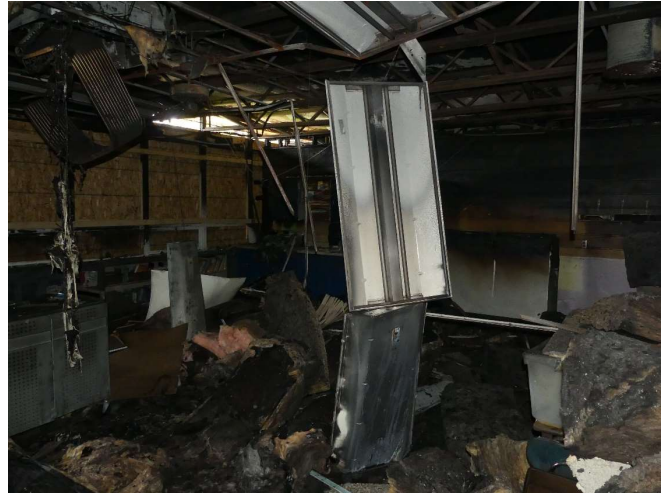
22. View into the west classroom in the east-west oriented building segment.

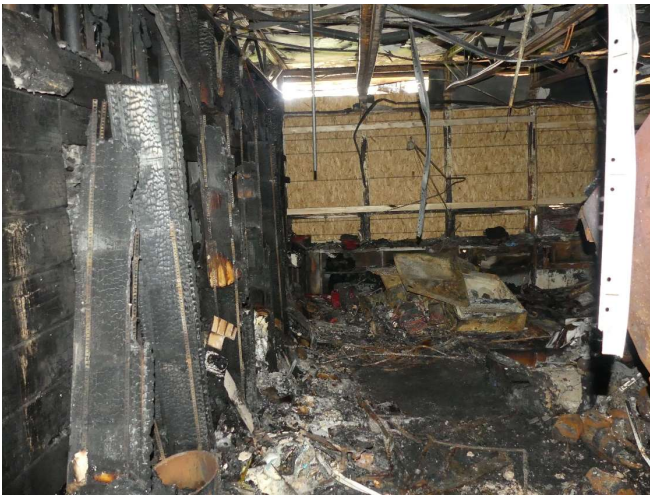
23. View into the kitchen area in the east-west oriented building segment.

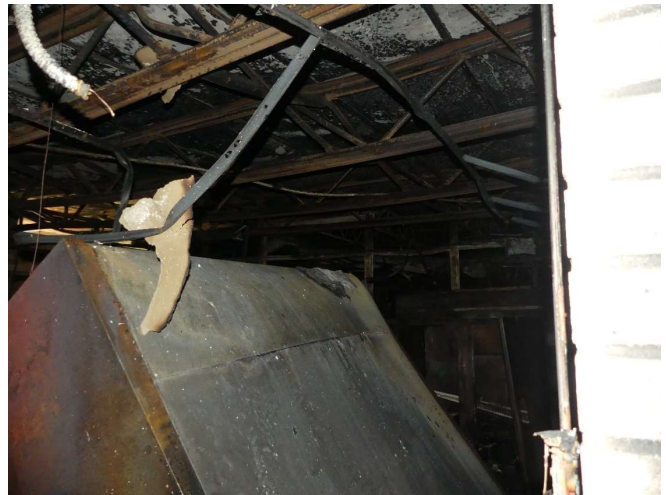
24. View into the kitchen.
