**Public Notice & Request for Qualifications for  
Construction Management at Risk (CMR) Services**

USD 216 Deerfield 803 Beech Street Deerfield, KS

High School – Middle School  
Campus and District Office  
803 Beech Street.  
Deerfield, KS.67838

## USD 216 Deerfield Building Needs Assessment Study September, 2021

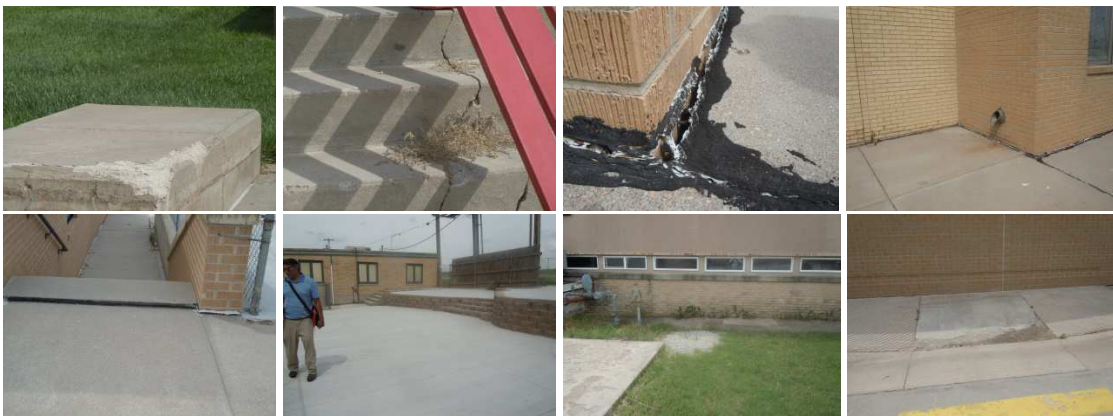
### Representative Site Pictures:

- The biggest concern with sidewalks is that they have settled next to, or pulled away from the building in numerous locations. The most damaging locations occur along the east side of the building. In some of these locations, the slope of the walk has reversed and slopes back into the building, causing deterioration to the brick next to the walk. This particular area needs to be addressed to avoid more serious damage to the building.

- A solution tried at the gaps along walls was an asphalt type filler to prevent water from entering. It may have provided some relief when new, but over time has lost its elasticity & cracked, shrunk and pulled out of the joint or away from the building, rendering its usefulness moot. It would appear that the original joints may not have been cleaned out and primed properly, and the material used was inappropriate for the location and useful life.

- The concrete paving at the handicapped curb cut on the north side has deteriorated to the point that it needs to be cut out and replaced.
- The sidewalk at the top of the NW stairs has settled to the point that it is a noticeable tripping hazard. This section of walk needs to be cut out and replaced, and pinned to the stair to prevent future settlement.

- The original concrete retaining piers at the south front of the High School are badly deteriorating and spalling, and the main entry stair between them has cracked and settled in the middle. This was the main entrance to the school, and it doesn't present a welcoming impression. It's time to replace them.

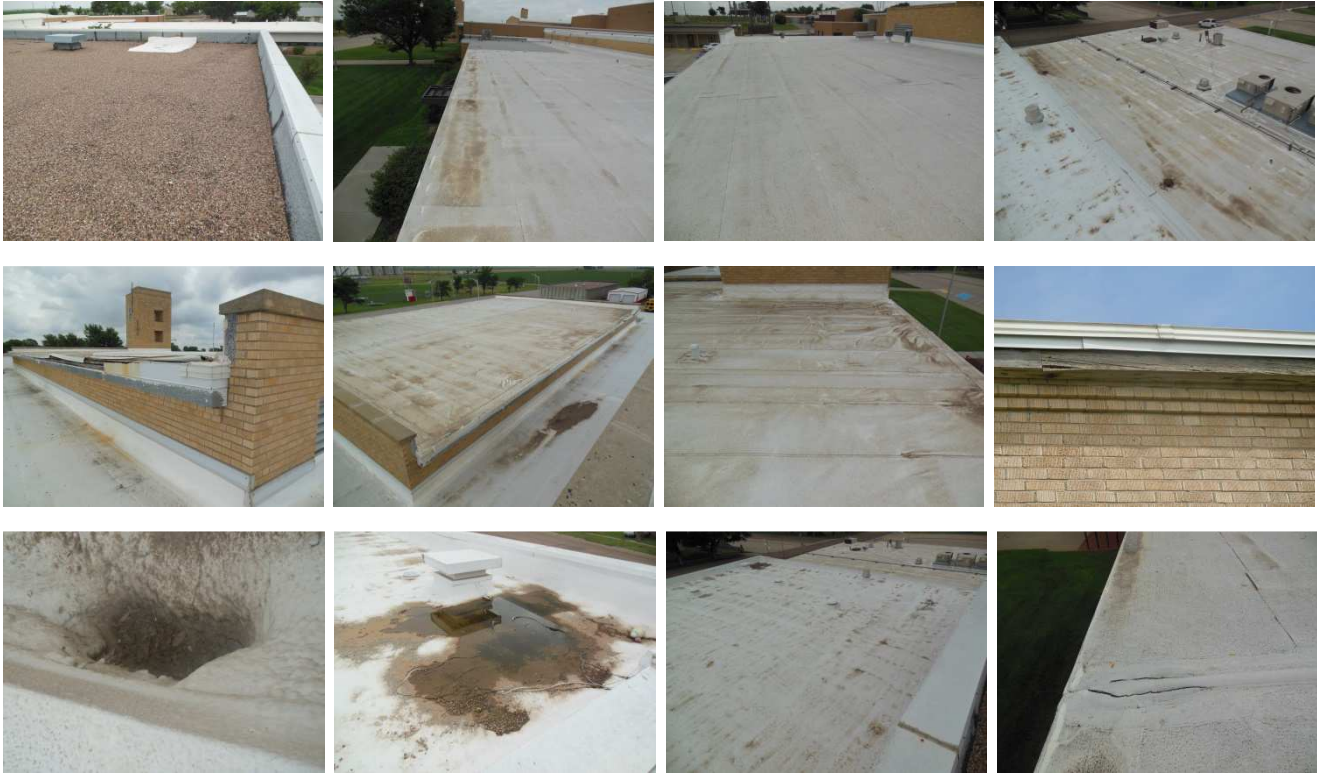
## Representative Roof Pictures:

- The new gym and second story mechanical roofs consist of built-up felts with tar and a gravel topping. A leak at the NE roof drains was patched with a white vinyl spray coating to stop the leaks.

- The roof over the science – library – offices, old gym, and the east classrooms at the '48 high school have modified roll roofing with some spray vinyl patches. It is reported that these roofs do not currently have any leaks, except that the area along the north side of the science rooms warrants observation.

- The final type that covers the rest of the building roofs consists of sprayed foam insulation with a sprayed vinyl topping. It is reported that these roofs do not currently have any leaks, but the lumpy nature of spray foam means that the roofs all have an abundance of bird baths that hold water and debris. The build-up of foam has also cause some areas to not drain as intended, such as some roof scuppers between the 1990 addition down to the 1988 addition at the north of the building. It was not clear if the sprayed foam was installed over the original roofing or if the old roofing was removed before the new sprayed foam was installed.

While the advantage of the sprayed foam and topping are that they are relatively cheap and quick, and add insulating value to older roofs, the disadvantages include difficulty in stripping the roof when needing to re-roof, the depressions collect dirt and make it difficult to find any damage to the topping. The topping thickness can vary if not properly applied, creating weak locations that are susceptible to damage from foot traffic, and hail stones. The over spray at edges is unsightly, not a clean look.

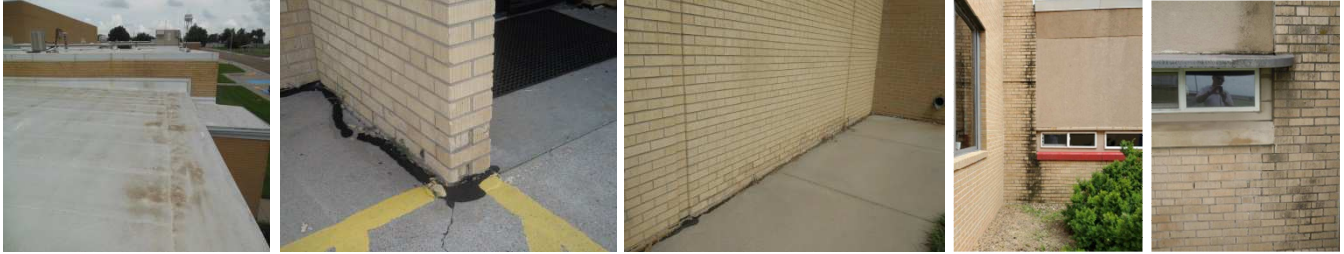
### Representative Brick Wall Pictures:

- Almost all of the control and expansion joints on the building have reached the end of their useful life. They are dried out, cracked, and have separated from the face of the brick, leaving open cracks and joints that will cause water infiltration and ultimately damage to the interior of the building. They should all be replaced at the same time with a high grade elastic type joint sealant.

- The brick at the NW corner of the old gym near the roof, and the SE corner of the science near the District office entrance has cracked and is in need of some tuck pointing of the mortar. There are numerous locations around the building where holes have been drilled for pipes or conduit, especially along the south façade. Some simple patch / tuck pointing is all that is required to repair these areas.

- The most damaged areas of brick are along the east wall at the sidewalk along the science room and middle school addition. At these locations, a combination of water discharge from roof leaders and the settling of sidewalks that allows the water to drain back to the building instead of away from it, has saturated the brick causing it to spall

off due to freeze –thaw action. The raked texture of the brick has fallen off, and the solid portion is now beginning to deteriorate considerably. This condition needs to be corrected to avoid further damage to the brick. similar deterioration is occurring at the west wall of the music room and at a couple of building entrances.

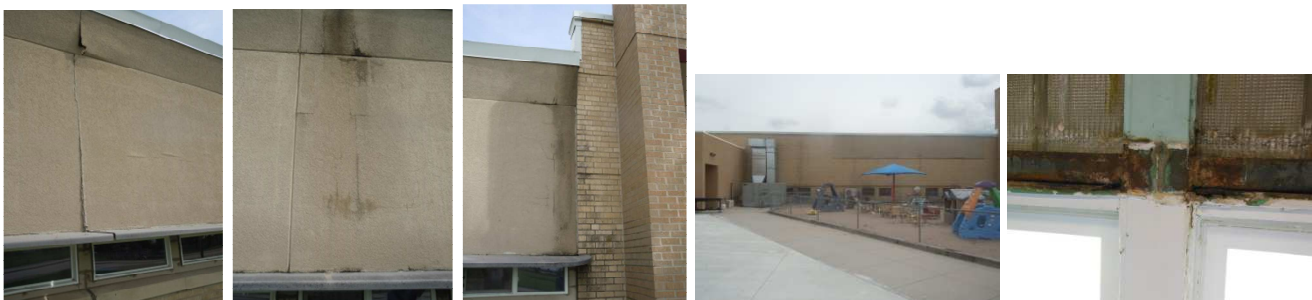
### Representative EIFS Wall Pictures:

**EXTERIOR EIFS Walls:** Some of the 1948 building's windows were covered in the past with foam panels and a thin synthetic stucco finish that is called Exterior Finish and Insulation System (EIFS). Many know it as Dryvit as that company was one of the first to introduce it to the US in the 80's. When installed correctly to appropriate substrates, it does its job well. ( it was installed correctly at the Elementary School and is in good shape there). At the High School, it was installed over the original glass block in the classrooms and the gymnasium. The decision to install it directly to the glass block was the first mistake, and the failure to adequately prevent water infiltration at the top, bottom and perimeter caused the entire system to fail. The caulking around the perimeter has failed, leading to damage at the finish face and foam of the EIFS, also allowing water to infiltrate into the original steel frames, which have in places rusted badly. Infiltration at the top has caused delamination of the foam from the block and caused warpage and cracking of the system finish on the front side. As is, the system is not repairable as a long term solution. It needs to be removed. The decision to replace it is tied to the decision on what to do with the window system. That will be discussed next in this report.

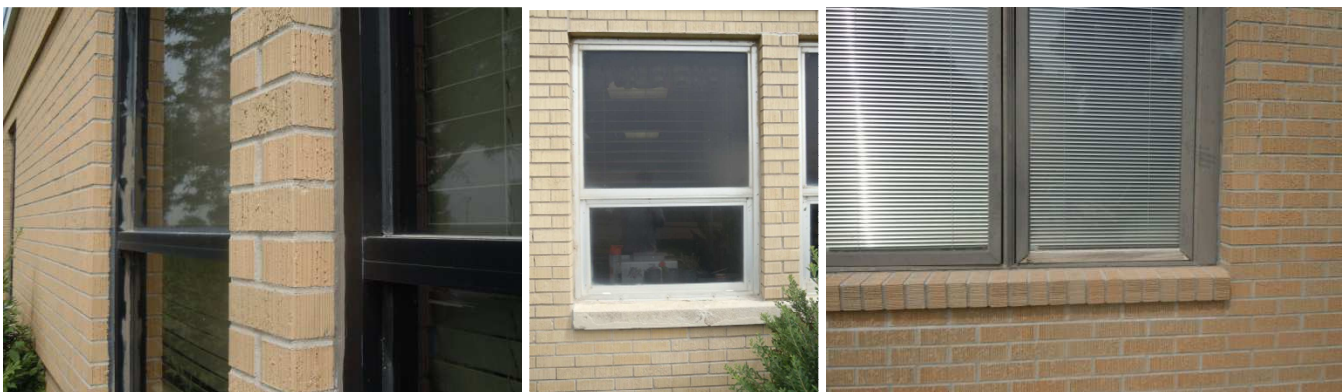
Representative 2012, and 1978 Window Pictures and Pella Window Picture:

- The 2012 windows are the newest and most energy efficient. The 1987 aluminum windows are all just a single pane without thermally broken frames. The only issues we saw were that the seal around the windows did not seem to be working very well as evidenced by the excessive amount of caulking that had been applied after the installation. The screens on the '87 windows were missing or damaged. The sills at the 2012 windows had issues and the '87 windows are plain anodized instead of the dark bronze anodized the district has been using for door replacement. Investigating the cause of the leakage around the windows and addressing that cause, is the most pressing issue. Due to the small quantity and size of the 1987 windows, unless you just want to replace them in a bigger window package, there is no long term payback, and I would not recommend replacing them. There are three single pane aluminum windows on the west side of the 1988 addition that appear to be in good condition, and in no need of replacement at this time.

- The Pella Windows on the 1990 addition are deteriorated beyond repair. The wood has been decayed due to moisture infiltration around the frames and internally at the corner joints of the window sashes. In addition, they are oversized casement windows, and in our windy environment, the window sashes have sagged to the point that they cannot be opened or closed and locked, without pulling the sash up from the outside. All of these Pella windows need to be replaced. Preferably with new thermally broken insulated glass aluminum windows.

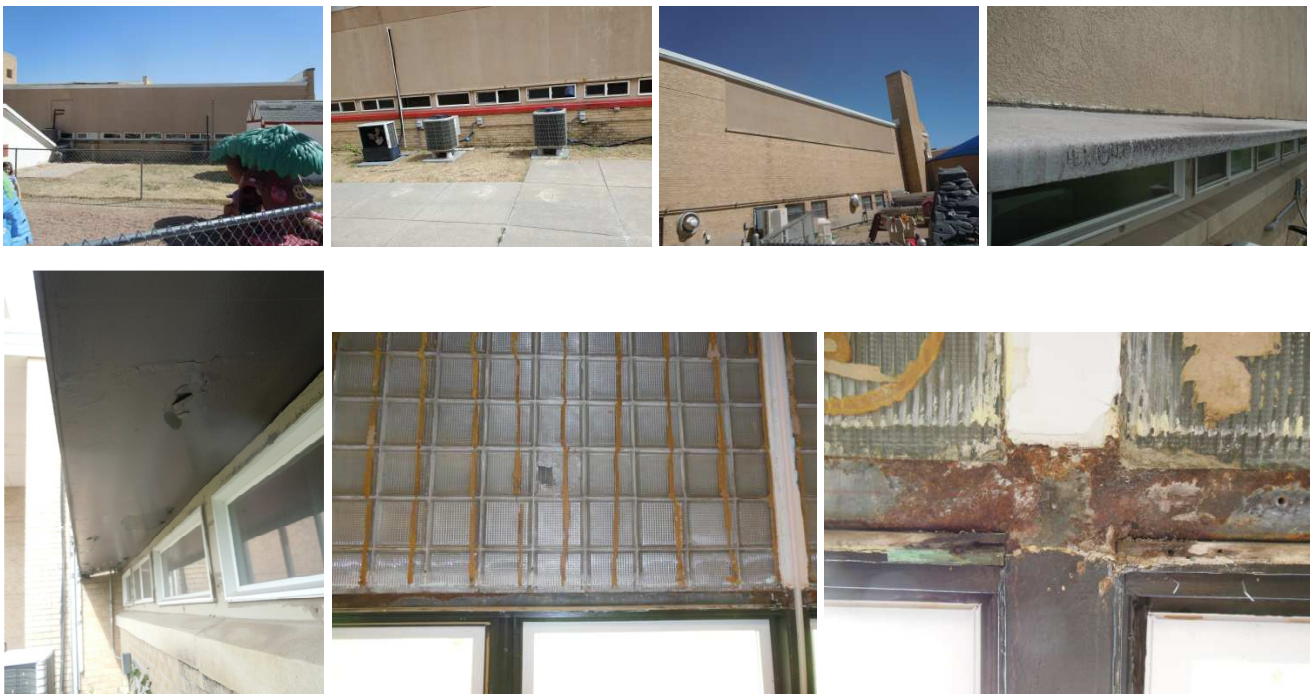
### Representative 1948 Window Pictures:

- At the 1948 building, the customary norm at the time was to install large glass block areas installed over smaller steel frame windows. The glass block provided diffused light throughout the classroom and gym without the need for blinds. In the 70's, glass block fell out of favor, and it became difficult to find matching block when one of them was broken. The fix was to either remove the glass block with new windows or infills, or to try to cover them with siding or other materials. In your case, the fix was to adhere EIFS directly to the glass block and glue siding to the inside of the block. It did provide a short term fix, but has now subsequently failed. The smaller steel sash windows below the glass block have more recently been removed with the space roughly filled in with wood and plank paneling and a combination of fixed and sliding, (very small) vinyl windows. What was a bit unusual about the construction detail at the original building, is that instead of a steel tube or beam between the steel sash and glass block, they installed a large steel horizontal 'Z' shaped plate that was flush with the steel columns on the inside, but extended out 2'-0" from the outside face of the windows, creating an overhang and shading device. If the bottom of the glass block had remained perfectly sealed the last 73 years, it would not be presenting an issue, but it did not remain sealed, and now has some real rusting and structural issues. As noted in the preceding EIFS section, the solution to these openings will not be easy. The solution(s) are a topic that we need to have with the board before proceeding to Part B of the report. There are some of the original steel sash windows remaining, primarily on the west side into the boys locker room. They are in relatively good shape. They need some paint and all of them need to be re-glazed with fresh putty. They all have single pane obscure glass. Unless there is a desire to replace them, we would recommend the touch-up / fix-up option. This decision may hinge on the disposition of the locker rooms, which will be discussed later in this report.

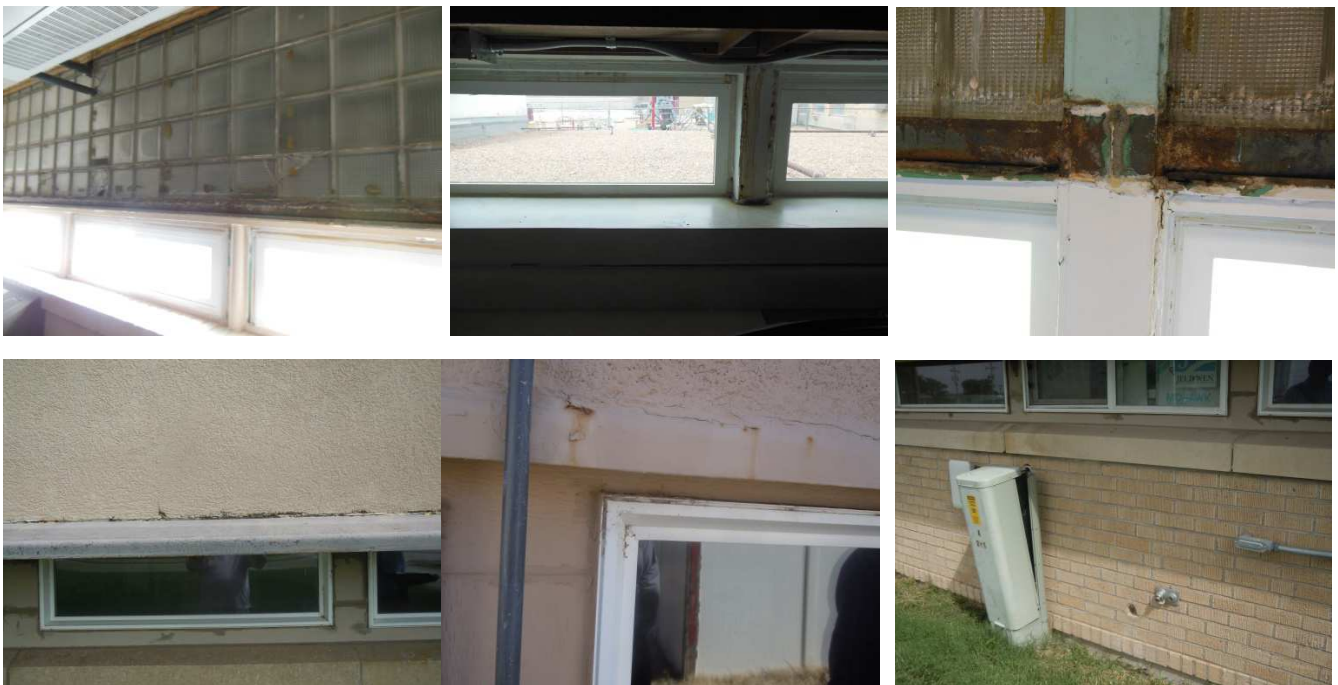
### Representative 1948 Vinyl Window Pictures:

- At the 1948 building, The smaller steel sash windows below the glass block have recently been removed with the space roughly filled in with wood and plank paneling, and a combination of fixed and sliding, (very small) vinyl windows. Because the EIFS applied over the glass block above, the steel shelf below the glass block has let water infiltrate through and caused issues with rusting to structural members. As noted in the preceding EIFS section, the solution to these openings will not be easy. The solution(s) are a topic that we need to have with the board before proceeding to Part B of the report. Aside from the fact that vinyl replacement windows were not the best choice for these areas, If the solution to the glass block and rusting steel shelf includes removal of either, than the decision to leave the vinyl windows is moot. If the shelf and block remain, than a discussion should be had regarding replacement or leaving the windows.

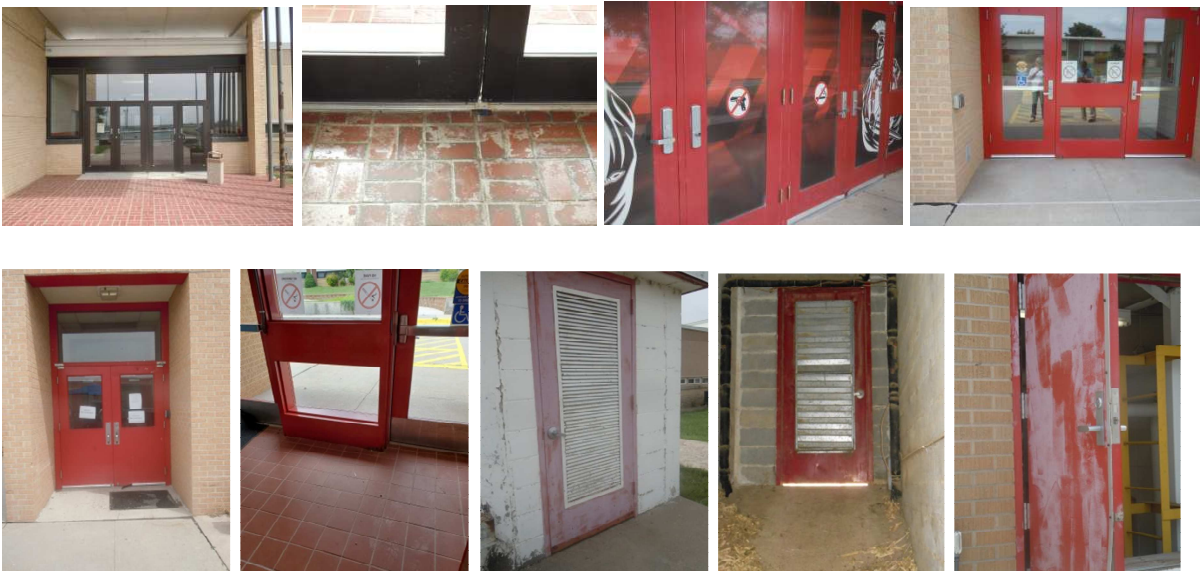
Representative Exterior Door & Frame Pictures:

- Both types of doors have issues with missing hardware and missing weather stripping. Some of these can be done as routine maintenance, and some would be better done by workmen experienced in installing door hardware.

- Many of the steel frames are rusting at the base of the frames. At the Pairs of north doors, the rust has eaten through the metal frames, both at the exterior and the interior. The choice will be to do some serious repair work to the steel, or to replace the doors and frames with Aluminum. Two utility room doors also need to be painted.

- Many of the entrances had recessed floor mats that have either been filled in or covered over, and several have tile / brick that have loose mats covering the flooring. Mats are a maintenance problem, and the recessed areas in some cases present a stumbling issue. It is recommended that all entrances be leveled up and covered with 'Walk-off' style entry carpet squares to improve debris-moisture control and care.

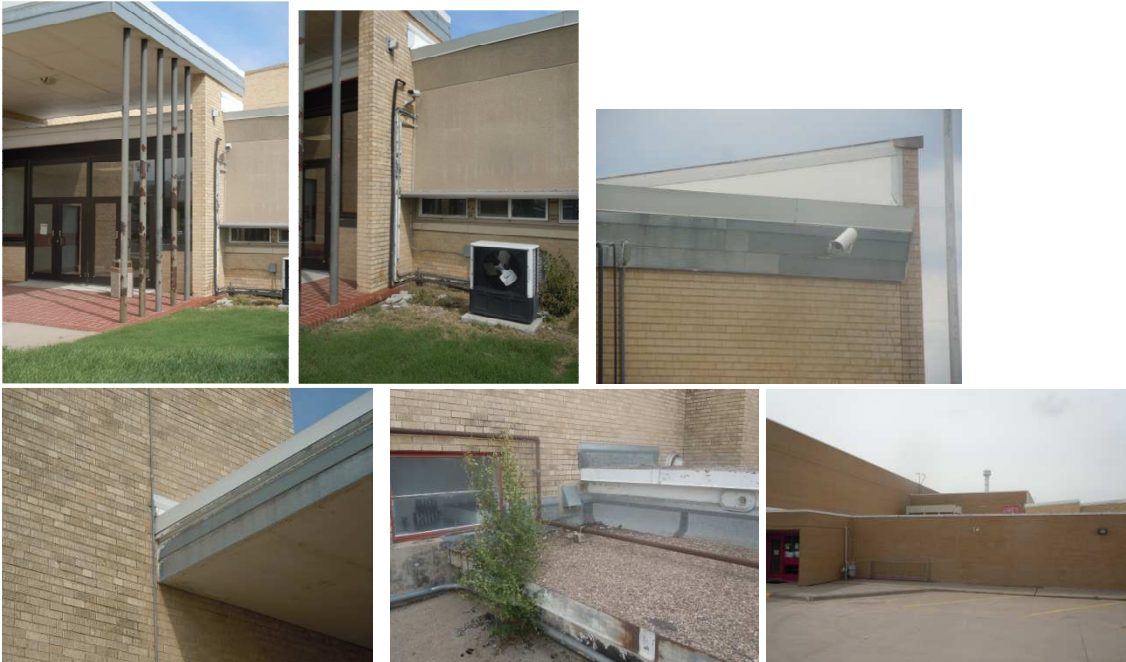
Representative Exterior Elements Pictures:

- **Steel post Entry Columns:** The entry canopy to the 1948 building has a series of five steel pipe posts supporting the east open side. All of the posts have chipped and faded paint, and most of them have a lot of rust forming. These need to be stripped down to the metal, primed and re-painted before the rust causes structural issues.

- **Fascia's:** The fascia's and roof trim is in generally good condition, except for the auditorium. That area would need to get new coping and trim if it is re-roofed, otherwise it needs some immediate attention. Other areas simply need to be painted.

- **Soffits:** The soffit at the main entry to the 1948 building, and the two on the east side are needing some minor repair at the joints and trim, and re-painting.

- **MEP Elements:** While some of the air condensers and other mechanical equipment is unsightly, the current mechanical systems requires them about where they are located. If new systems are installed, some better options may be available. The issues we found that need addressing is that the foam insulation around refrigerant piping is deteriorated due to weather and UV degradation, and in need of replacement. In addition the holes drilled in the brick for these lines and also electrical conduit, were either not sealed properly or the sealant had dried out leaving gaps. Replacement and re-sealing at these areas should be done soon.

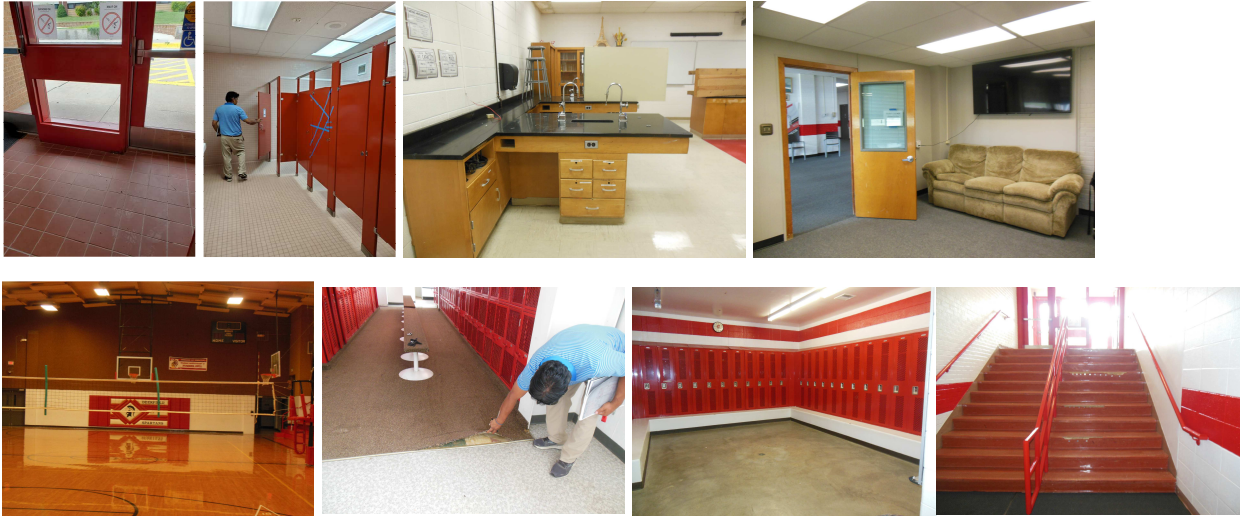
## Representative Interior Floor Pictures:

- **FLOORS:** The floor types include Vinyl Compositions Tile (VCT) in various classrooms and hallways, Sheet vinyl in the FACS, lower locker rooms and sewing, Wood Floors in the both gym, sealed concrete in the new locker rooms and various utility rooms, Ceramic Tile at several entry's and in the new locker shower rooms & toilets, and Carpet throughout the rest of the building. Some of the flooring is in decent condition. And some will need replacement soon. We also observed a couple of rooms that have 8x8 asbestos tile floors that should be addressed if work is done in those rooms. We would recommend that any future carpet replacement be with carpet tiles instead of roll goods due to its better durability, and the ability to replace a damaged tile easily. The stain treads and nosing at the two north entryways are used by students going to lunch at the Elementary school and patrons during events in the new gym. They have become worn and damaged beyond repair and should be replaced. It was reported that both of the gym floors are at or near the point where they cannot be sanded down anymore. At that point, they will need to be budgeted for replacement, and a decision would need to be made to replace the old gym floor with new wood or a synthetic surface.

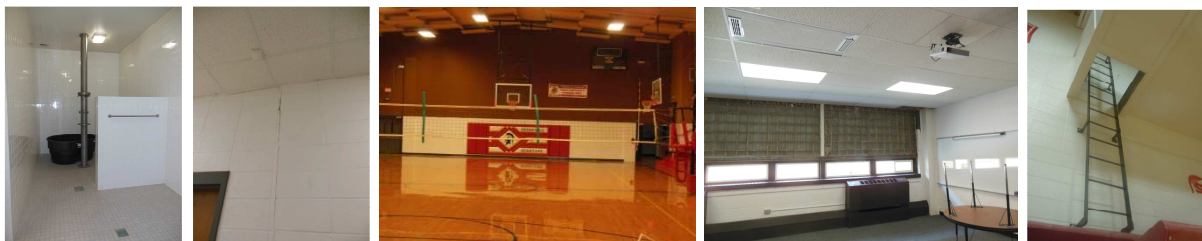
## Representative Interior Wall Pictures:

- **WALLS:** Walls are generally painted concrete block, painted brick, ceramic tile installed at the toilets and shower areas, and misc. painted drywall walls. Some of the walls in the old gym have carpet on the walls as an acoustical material. All of the walls are in generally good condition. The carpet on the walls of the old gym does not meet any building or fire codes, and should be replaced if possible. There are some minor cracks and dings, and several of the control and expansion joints have dried out and failed. These should be tuck points and replaced with new caulk. Continued general maintenance is all that is recommended. The most pronounced wall cracks are in the auditorium. While they may be old cracks, they may warrant a simple test device across them to monitor if they are stable or still moving.

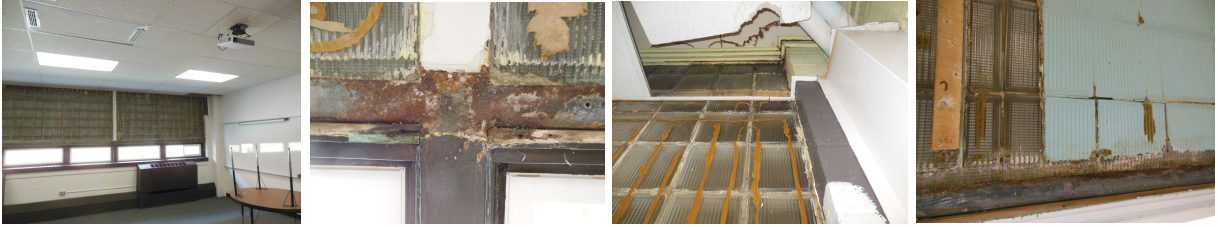
### Representative Interior Window Pictures:

- **WINDOWS:** The descriptions in the above Exterior window portion of the report describes in mirror what the windows are doing on the interior of the building. Sills at windows that leak or have been heavily caulked have sometimes been damaged and need replacing. Most of the sills at Pella windows will need replacing. What to do with the old glass block windows in the 1948 classrooms will be one of the more important decisions the board will need to address.

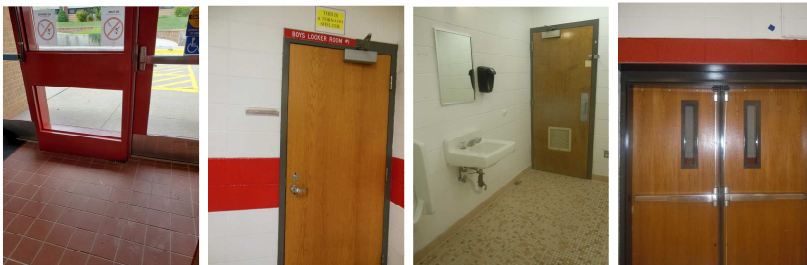
### Representative Interior Window Pictures:

- **DOORS:** The doors on the inside of the building are in generally good condition. Most door hardware is ADA compliant, and most doors and frames only have normal wear and tear, needing only routine maintenance. Entrance doors and floor mats were covered in the Exterior portion of the report. It is worth reiterating that installing walk-off carpet tiles at the entryways will work much better than all of the loose mats, and save the maintenance staff considerable time now spent on maintaining the loose mats. The door hardware at the boys locker room has been changed at some point, but the replacement hardware is inappropriate for the door. The door locking devices at the two toilets near the science room need to be replaced with a compliant type lock. One set of doors in the new gym has damaged and missing pieces on the flush bolt latching devices, and the devices need to be replaced.

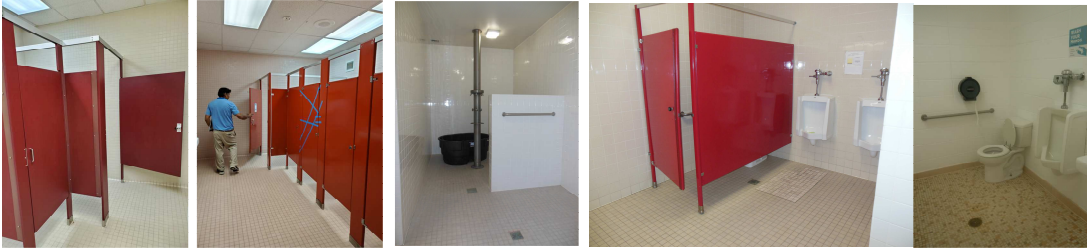
### Representative Interior Toilet and Locker Room Pictures:

- **TOILETS and LOCKER ROOMS:** None of the existing toilets or locker rooms in the entire building are compliant with ADA accessibility guidelines, and except for the pair of toilets east of the new gym, none of them are easily modified to make them compliant. The last addition in 1990 came the year before the ADA became law, so the designs at the time were OK, but Public Accommodation in schools do not get a pass for bringing the facility into compliance. What to do to bring the facility into compliance needs to be discussed. A decision will need to be made as to keeping the existing locker rooms and constructing a pair of accessible toilets / locker rooms on the main level, or constructing new locker rooms to accommodate all students for gym class. It may be possible to sacrifice a classroom on the main level to accomplish this or construct a small addition near the old gym.

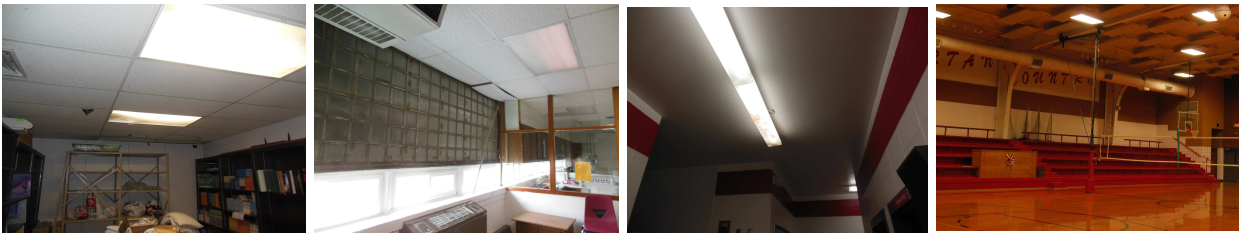
### Representative Interior Lighting Pictures:

- **LIGHTING:** The lighting was good in some areas and sub-par in other older areas of the building. We would recommend that the staff continue replacing bulbs in the classrooms with LED's so that the light is brighter and all the same color. Some of the fixtures should be replaced with new LED fixtures as the age of the fixture prohibits installation of new ballasts. And some of the fixtures are damaged and inadequate for a good learning environment. Adding motion sensors to the switching of lighting in frequently vacated rooms will save a considerable amount of energy and money. Rooms we thought were poorly lit included the science room, library, FASC Room, the old gym, Locker rooms

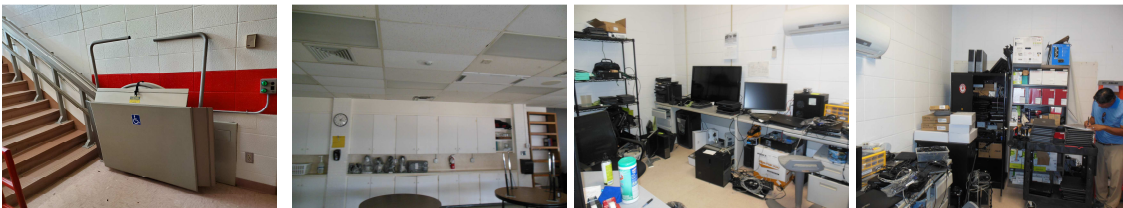
### Representative Interior Elements Pictures:

- **INTERIOR ELEMENTS AND ADA ISSUES:** Most areas of the school are accessible. Some doors are not wide enough, and some but not many, do not have the required clearance by their latch side to be accessible. The lift at the north stair has solved the access issue for students and gym patrons.
- The casework condition varies throughout the school. Most is serviceable, but some has simply worn out. Very little is designed to meet any ADA standards, but there is generally room to fit an accommodating piece into a room if needed.
- The IT guy needs a bigger – better space to work.

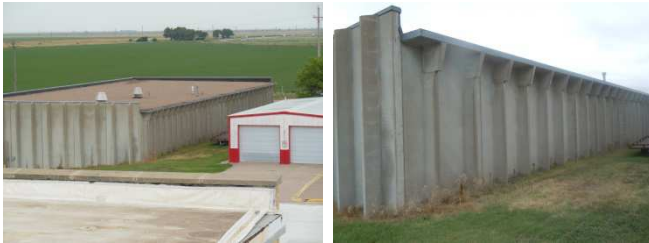
Representative Roof Pictures:

**ROOF:** Staff reported that most of the roof is leak free at this time. It is a built up roof with a gravel topping. It is unknown if it is original or has been re-roofed. The galvanized metal roof edges and caps need to be cleaned and painted to ward off future deterioration and rust issues.

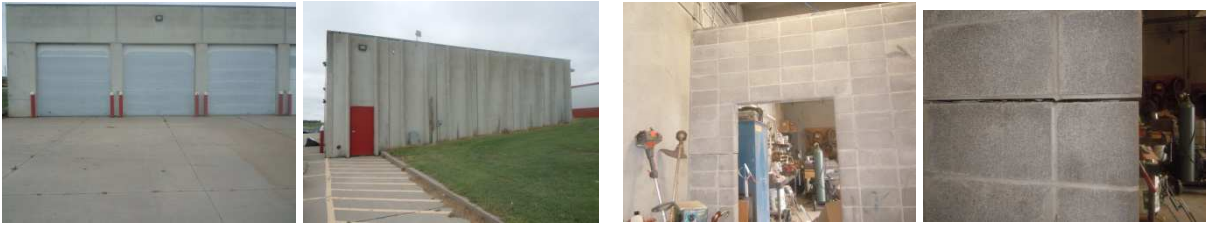
Representative Exterior Door & Frames and interior cracked wall Pictures:

- The condition of the walls is good, but all of the caulking joints between panels are dried out, cracked, pulled away from the concrete face and have out-lived their useful life. They should all be replaced at the same time with a more elastic type joint sealant. The panels should continue to protect the building for many decades to come.

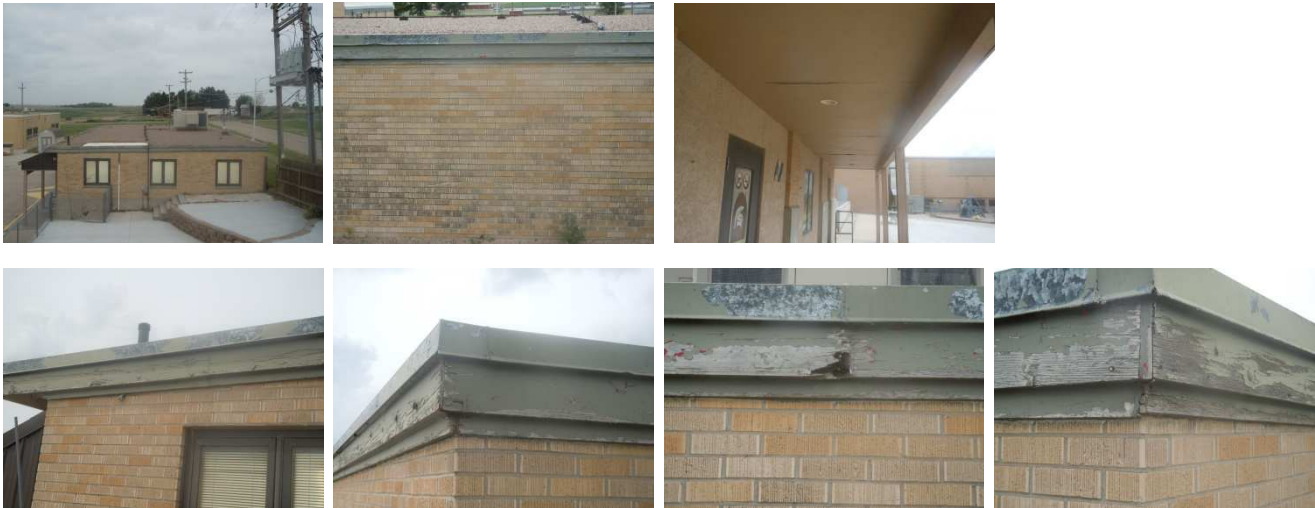
Representative Brick, window and Roof Pictures:

**ROOF:** Staff reported that after a recent patch, the roof is now leak free. The roof is a tar and gravel type roof with no original insulation. The drawings of the 1993 remodeling of the Bus Barn into the pre-school did not include a re-roofing of the building, and it is unknown when the last re-roofing took place. The assumed insulating value of the roof is insignificant. Any future re-roofing should include stripping the roof to the wood deck, adding board foam insulation to the existing structure, and repairing the wood edge/ fascia boards before re-roofing.

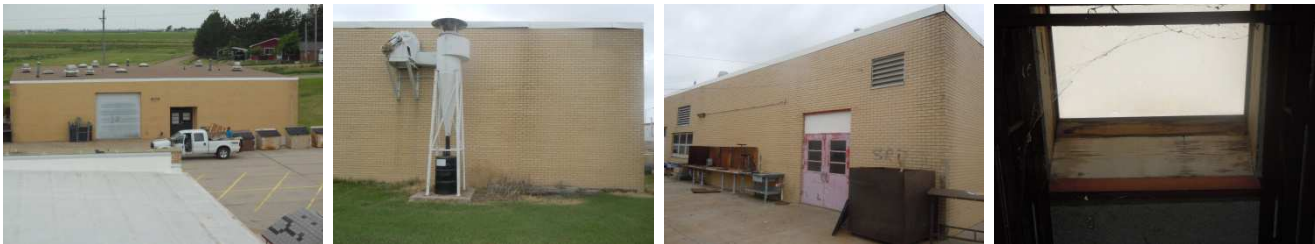
### Representative Roof Pictures:

**ROOF:** Staff reported that the roof is leak free at this time. It is a built up roof with a gravel topping over 1" of insulation board and a 2" wood fiber/cement deck called Tectum.

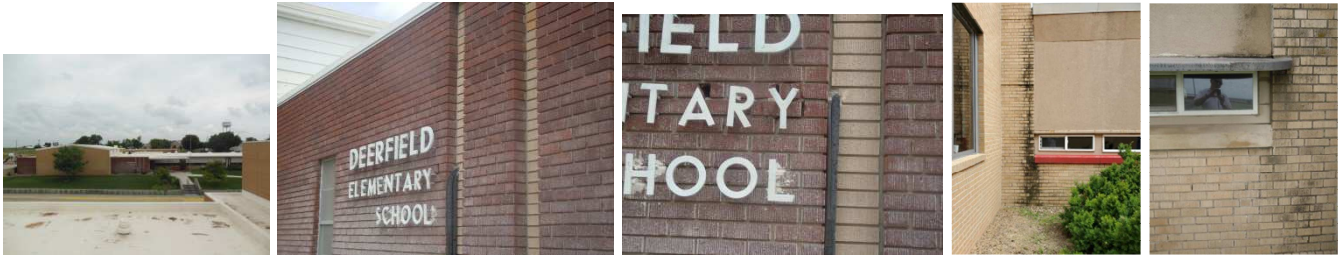
### Representative Brick Wall Pictures:

BRICK WALLS: The majority of the building is constructed with Blond and Deep Red Brick that has a 'vertical scratch' finish instead of a smooth finish. The condition at most of the brick and mortar is good, with few cracks or loose mortar. The masonry should continue to protect the building for many decades to come. There are a few exceptions that need some attention or repairs. Observed areas needing attention include the following:

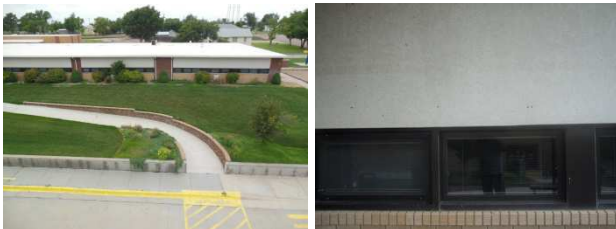
### Representative EIFS Wall Pictures:

**EIFS WALLS:** Some of the 1957 building's windows were covered in the past with foam panels and a thin synthetic stucco finish that is called Exterior Finish and Insulation System (EIFS). Many know it as Dryvit as that company was one of the first to introduce it to the US in the 80's. When installed correctly to appropriate substrates, it does its job well. It was installed correctly at the Elementary School and is in good shape with just a few patches at occupant drilled holes, and some re-sealing around the perimeters to ensure water tightness.
