**Public Notice & Request for Qualifications for  
Construction Management at Risk (CMR) Services**

USD 216 Deerfield 803 Beech Street Deerfield, KS

High School – Middle School  
Campus and District Office  
803 Beech Street.  
Deerfield, KS.67838

## USD 216 Deerfield Building Needs Assessment Study September, 2021

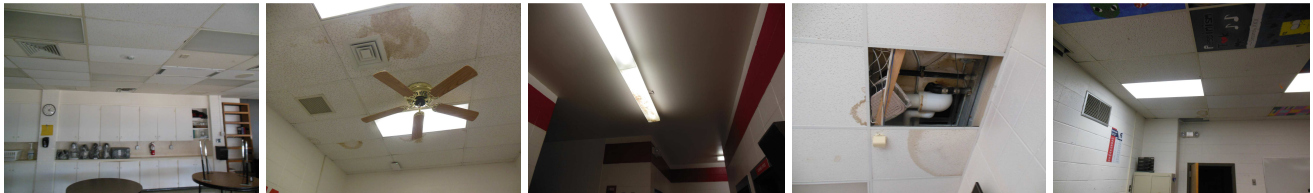
Representative Interior Ceiling Pictures:

- **CEILINGS:** The ceilings in most of the building have some staining issues from roof and plumbing leaks. The ceilings suffer from not having the same style / texture of ceiling tile throughout and from being different ages, so the colors have aged at different rates. These two issues are very pronounced when a ceiling tile is replaced and doesn't come close to matching the adjacent tiles. The ceilings in the science room and the FACS room are particularly bad and should probably just be replaced. A good strategy is to establish a standard manufacturer and style of tile, and use that tile for all new replacements of rooms. A phased solution to the different style and different age problem is to change out the tile in an entire room adjacent to these various aged areas, and use the good tiles from that room as replacements for stained or damaged tiles in the adjacent rooms. Over time all rooms would get new replacement tiles.

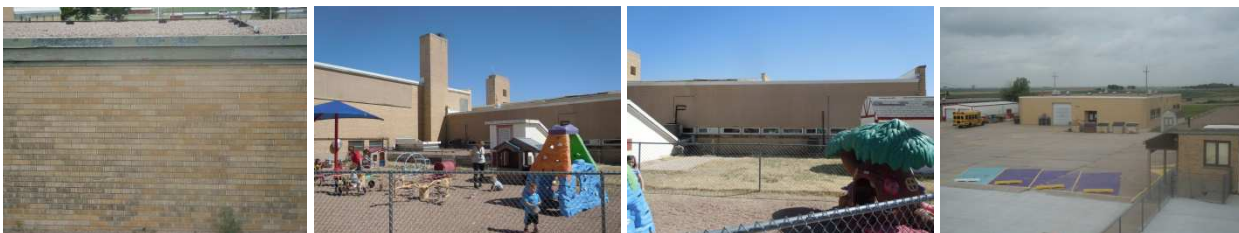
Representative Site Pictures:

**SITE ELEMENTS:** The only site element is the pre-school play ground that is east of the building and enclosed with a 4' high chain link fence. The play elements seem appropriate, but the ground surface is all pea gravel, somewhat retained by old railroad ties. If the Pre-School is retained, you may want to consider an alternative type ground surface for the children's comfort and safer traction.

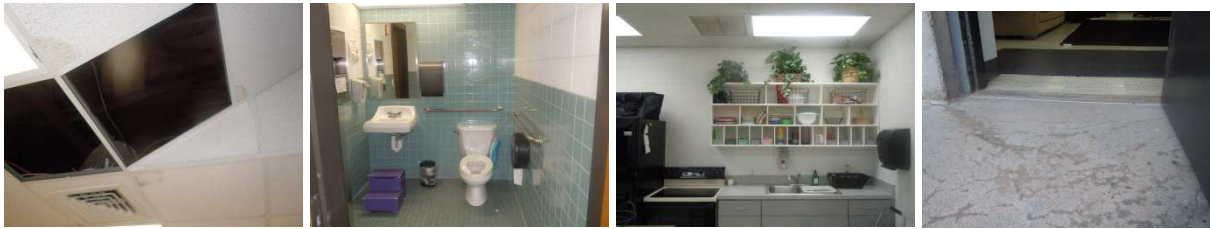
Representative Interior Pictures:

- The exterior doors are flush with the exterior walk, and the existing thresholds are letting in some moisture and dirt. Adding some gasketing to the bottom of the door or changing the type of threshold would solve this issue.
- The size of the water closet fixtures in the two toilets are adult size. Installing a small child size water closet in the toilet that is accessible from both class rooms would be advisable.
- The range needs to have an exhaust hood installed over it.
- A few damaged ceiling tiles need to be replaced.

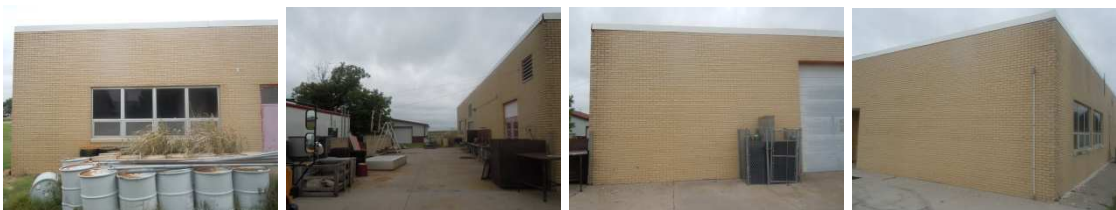
Representative Site Pictures:

**SITE ELEMENTS:** There aren't many site elements at the Vocational Building. The only item we saw needing any work was repairs to the small fenced area for the welding tanks. ADA access to the building appears to be in general compliance.

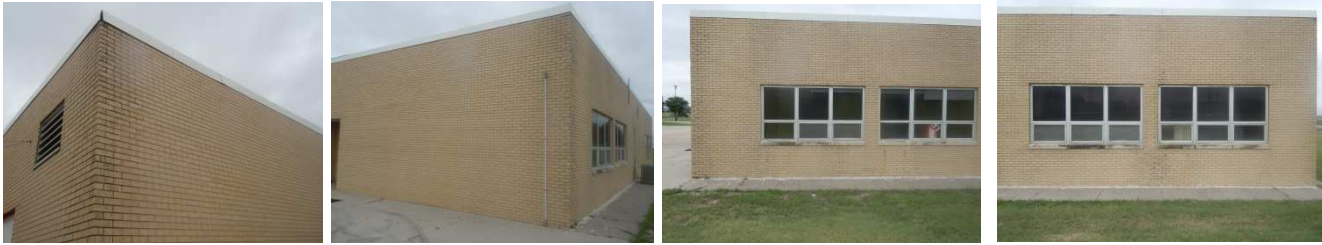
### Representative Brick Wall Pictures:

- There are several locations around the building where holes have been drilled for pipes or conduit. Some simple patch / tuck pointing is all that is required to repair these areas.

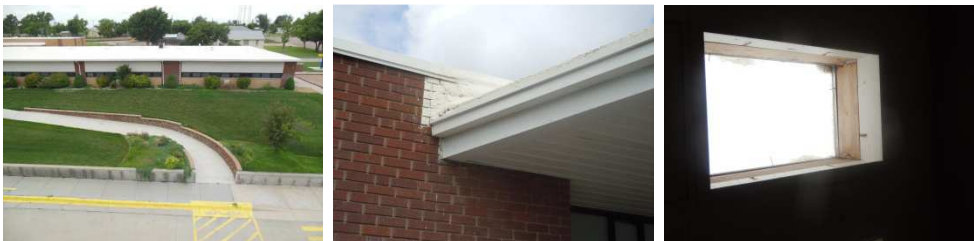
## Representative Roof Pictures:

ROOF: Staff reported that the roofs were re-done with spray foam and vinyl coating two years ago, and are leak free at this time.

- The 1957 roofs all drain to the sides. The building has gutters and downspouts that work reasonably well. Some Gutter and downspout in the courtyard area is PVC and was damaged during the recent hail storm. It is recommended that replacement be with metal gutters and downspouts.
- The metal flashing and roof edges are generally good, with some just needing paint. The spray foam has in places caused a messy look and overspray of topping at several location.
- There are a few old deteriorating skylights in the '57 portion of the building that may want to be either eliminated or replaced.

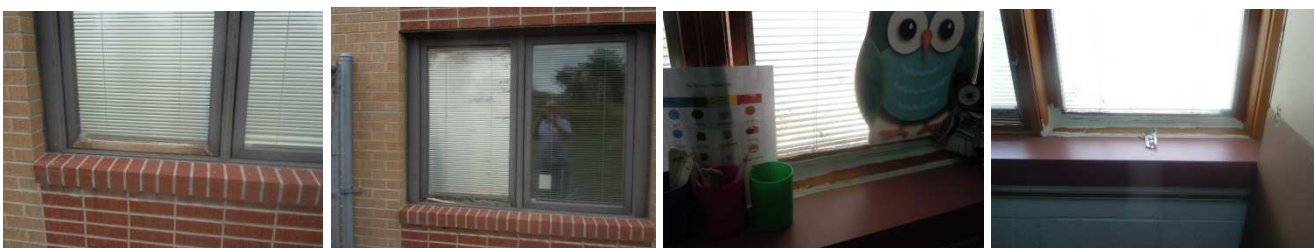
Representative Pella Window Pictures:

- The Pella Windows on the 1990 addition are deteriorated beyond repair. The wood has been decayed due to moisture infiltration around the frames and internally at the corner joints of the window sashes. In addition, they are oversized casement windows, and in our windy environment, the window sashes have sagged to the point that they cannot be opened or closed and locked. All of these Pella windows need to be replaced. Preferably with new thermally broken insulated glass aluminum windows.

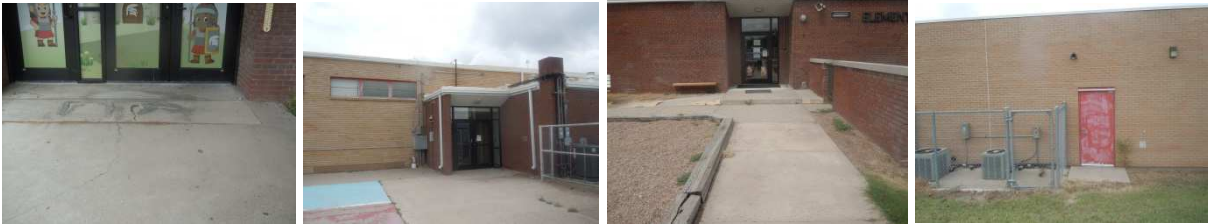
### Representative Exterior Door & Frame Pictures:

Many of the entrances had recessed floor mats that have either been filled in or covered over, and several have tile / brick that have loose mats covering the flooring. Mats are a maintenance problem, and the recessed areas in some cases present a stumbling issue. It is recommended that all entrances be leveled up and covered with 'Walk-off' style entry carpet squares to improve debris-moisture control and care.

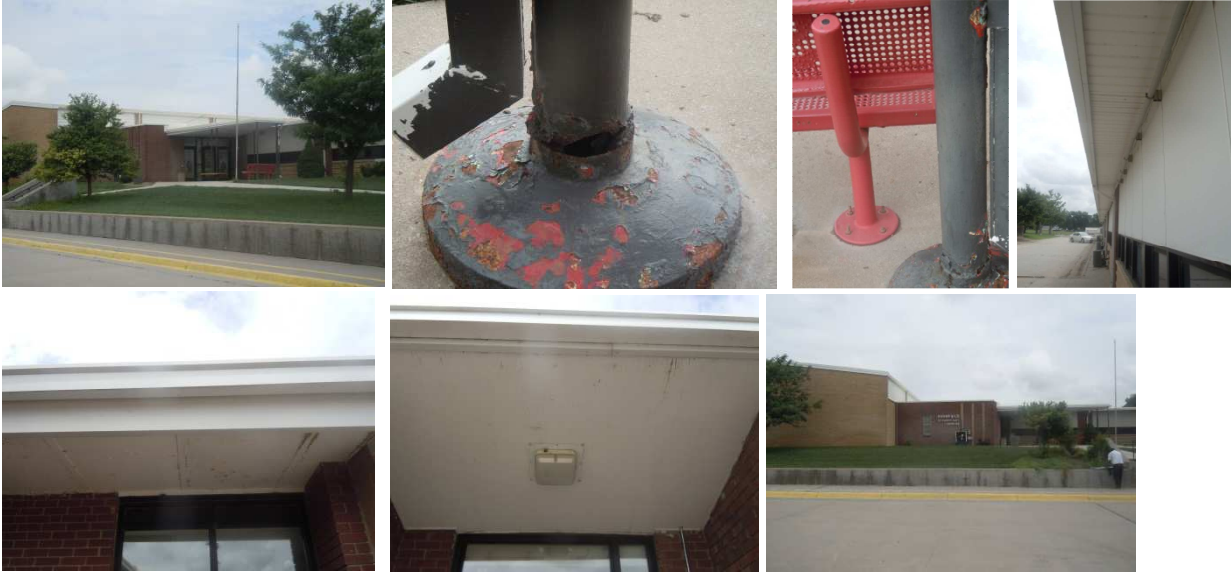
Representative Exterior Elements Pictures:

- **Steel post Entry Columns:** The entry canopy to the 1957 building has a series of five steel pipe posts supporting the overhang roof. All of the posts have chipped and have faded paint. Most of them have a lot of rust forming. Some of them have extreme rust damage at the base that needs to be addressed very soon. From observation, two of the posts have had structural issues before and repairs were unsuccessfully attempted. Our recommendation is that these two posts be replaced or have a large section cut out and replaced. All of the posts need to be stripped down to the metal, primed and re-painted before the rust causes structural issues.

- **MEP Elements:** While some of the air condensers and other mechanical equipment is unsightly, the current mechanical systems need them about where they are. If new systems are installed, some better options may be available. The issues we found that need addressing is that the foam insulation around refrigerant piping is deteriorated due to weather and UV degradation, and in need of replacement. The condensing unit at the front of the building directly under the school sign has settled and is tilting, and has a tree growing behind it. If it is to be retained, the pad needs to be re-poured and the unit re-set. In addition the holes drilled in the brick for these lines and also electrical conduit, were either not sealed properly or the sealant had dried out leaving gaps. Replacement and re-sealing at these areas should be done soon.

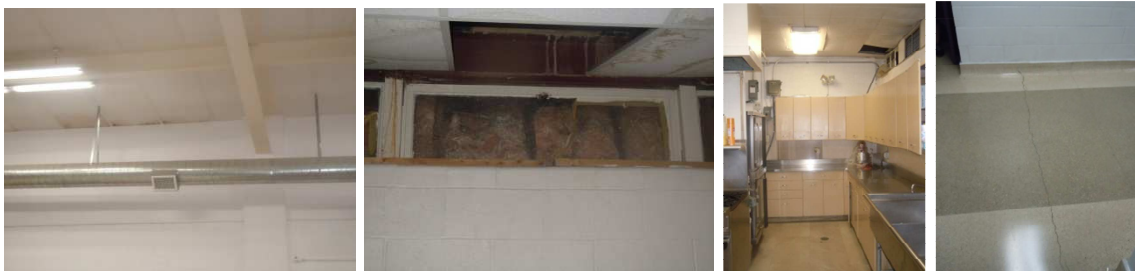
Representative Interior Elements Pictures:

- **BASEMENT LEVEL:** The basement is not a very finished space, and is also used as a tornado shelter. While it is the safest place to be in severe weather, it is not build to current ICC-500 or FEMA tornado shelter standards, nor could it be retro fitted to be compliant. We would recommend that it just be referred to as a shelter in all signage and written documents.
